MEMO

On Wednesday, September 21, 2016, seven archaeologists from the State Historical Society of North Dakota (SHSND) conducted a pedestrian inventory (cultural resources survey) of the 1.36 mile long Dakota Access Pipeline (DAPL) project construction corridor in Morton County west of North Dakota Highway 1806 under considered review, at the request of the joint Law Enforcement Task Force formed to investigate the DAPL project (see Figure 1 attached).

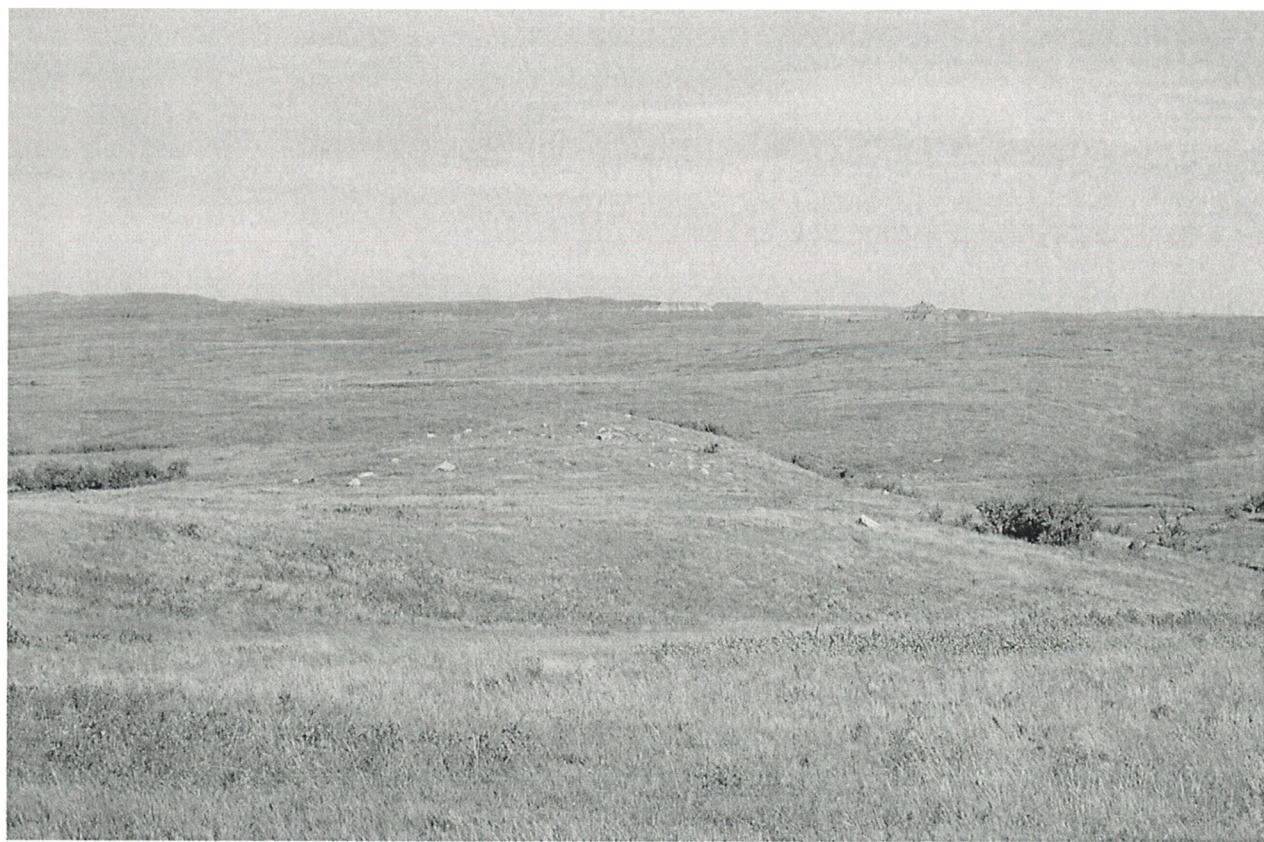
Figure 2. Photograph of glacial erratics exposed on hilltops adjacent to the inventory area.

The survey corridor environs comprised rolling upland prairie grasslands west of the Missouri River bisected by shallow ephemeral drainages. Glacial erratics (bowling ball to car sized) were exposed on hilltops and side slopes along the length of the survey corridor project area (see Figures 2-3 attached).

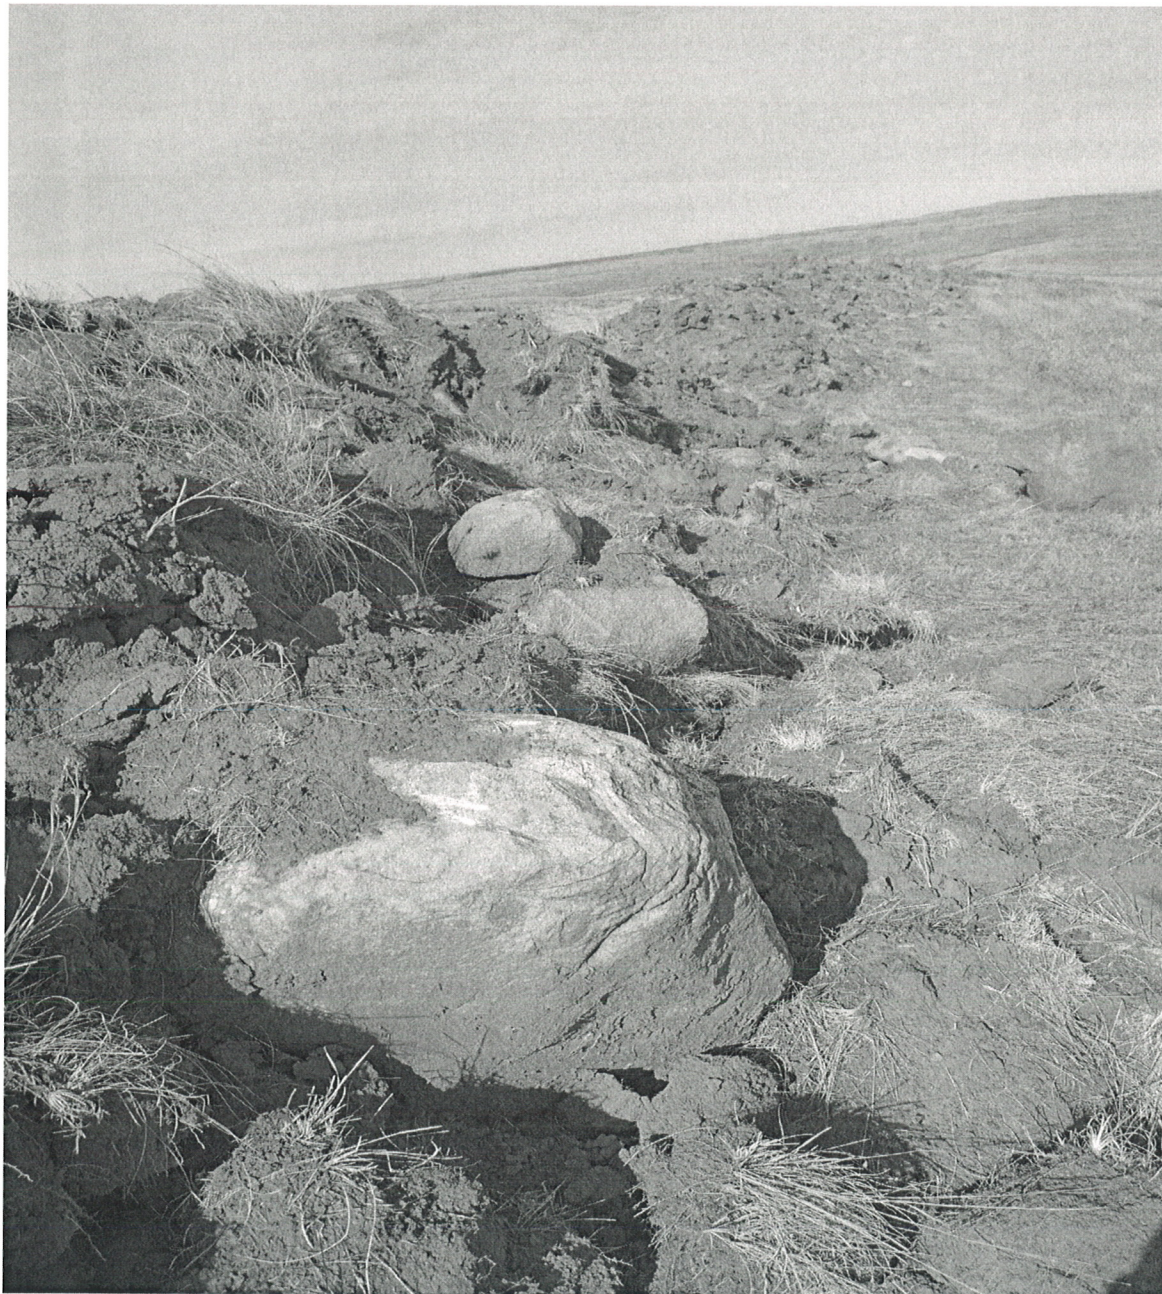
Figure 3. Photograph of glacial erratics in topsoil berm in the construction corridor.

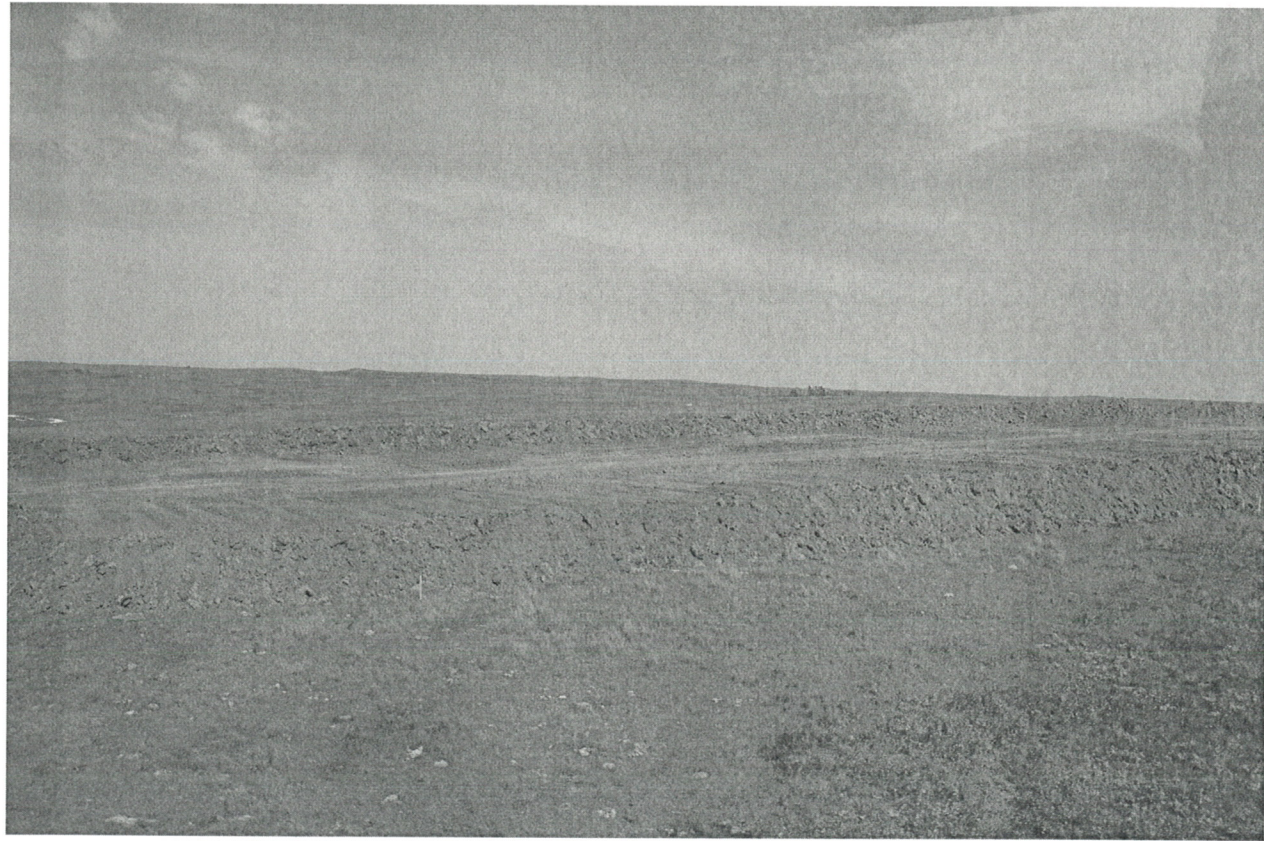
Figure 4. Photograph of the Dakota Access Pipeline construction corridor inventory area showing stripped surface and stockpiled topsoil berms along the lateral margins.

The DAPL construction corridor had been stripped with topsoil stockpiled along the lateral margins (see Figure 4 attached). SHSND archaeologists traversed the corridor at seven-meter interval spacing inspecting the stripped ground surface and both sides of the two opposing stockpiled topsoil berms along the lateral margins of the corridor.
